### STM32L431xx device errata

This document applies to the part numbers of STM32L431xx devices and the device variants as stated in this page. It gives a summary and a description of the device errata, with respect to the device datasheet and reference manual RM394. Deviation of the real device behavior from the intended device behavior is considered to be a device limitation. Deviation of the description in the reference manual or the datasheet from the intended device behavior is considered to be a documentation erratum. The term “errata” applies both to limitations and documentation errata.

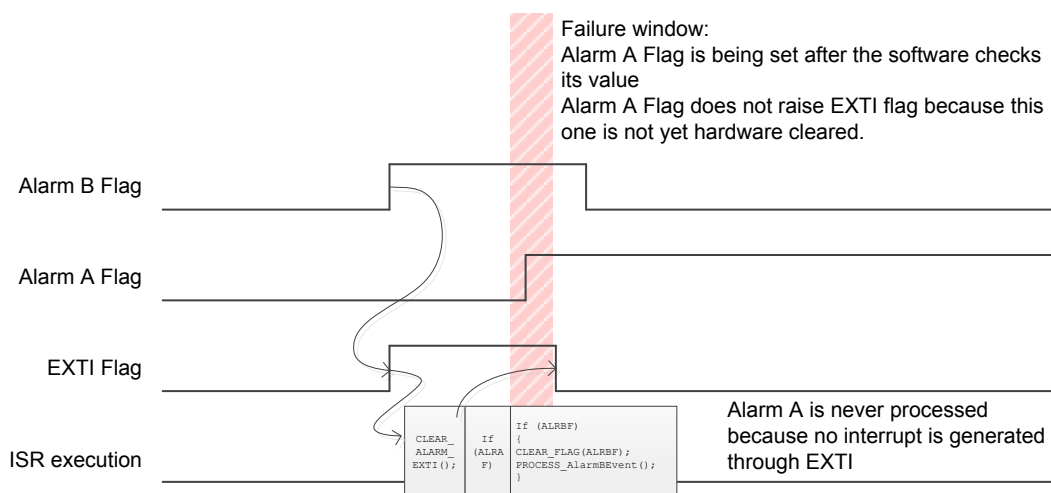
**Figure 1. Masked RTC interrupt**

The following code example and figure illustrate the failure mechanism: The Alarm A event is lost (fails to generate interrupt) as it occurs in the failure window, that is, after checking the Alarm A event flag but before the effective clear of the EXTI interrupt flag by hardware. The effective clear of the EXTI interrupt flag is delayed with respect to the software instruction to clear it.

In the interrupt service routine, apply three consecutive event flag checks - source one, source two, and source one again, as in the following code example:
